Manhole Inspection Summary

Manhole # S27S__005MH

Location Address: **1600 Wicomico st**

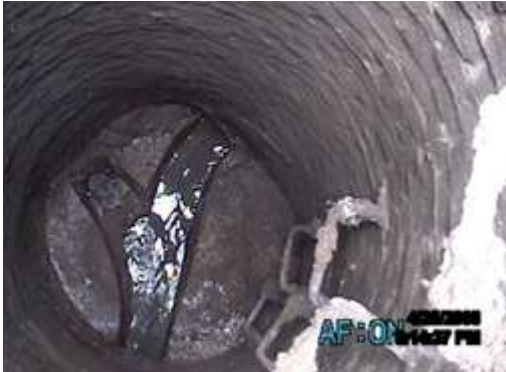
Defect 6

Infiltration: ☐ None ☐ Joint ☐ Cracks ☐ Mortar ☐ Roots ☒ **Wall**

infiltration in barrel

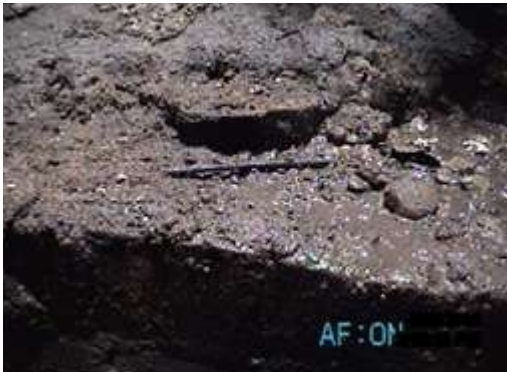
Defect 5

Condition: ☐ Sound ☐ Cracked ☐ Root Intrusion ☐ Deteriorated ☐ Leaks ☒ **Debris**

debris on bench

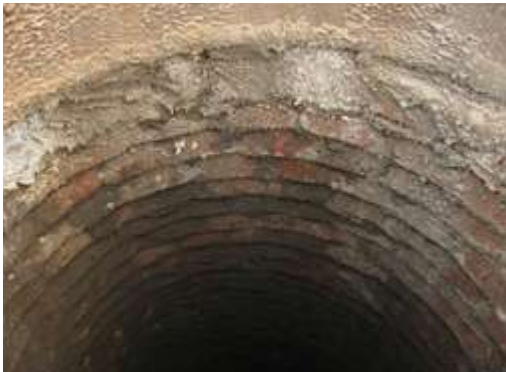
Defect 3

Infiltration: ☐ None ☐ Joint ☐ Cracks ☐ Mortar ☐ Roots ☒ **Wall**

sign of infiltration at chimney and corbel

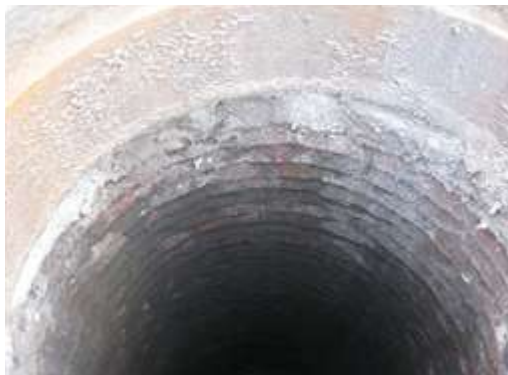
Defect 2

infiltration lid and chimney

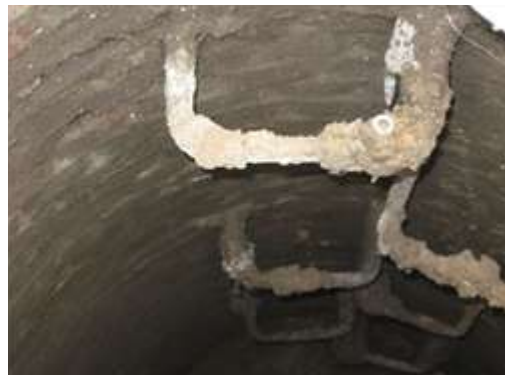
Defect 1

Count: **7** Missing: **0** ☒ **Corroded**

☒ **Evidence Of Surcharge** Depth: **8** (ft.) ☐ Active Surcharge Present

signs of surcharge, corroded rungs as well as possible infiltration

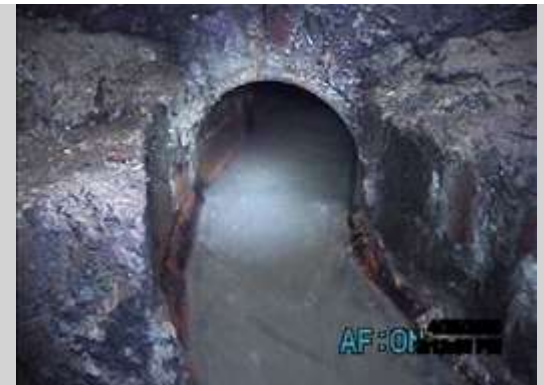
7 O'Clock Inflow

10 in. Circular Gravity Sewer
Pipe In @ 7 O'Clock

Pipe Height: **10.8** (in.) Rod and Bar (Angled)
Pipe Material: **Clay** ☐ Pipe Lined
Invert Depth: **13.06** (ft.) Flow Characteristics: **Slow**
Deposits: ☒ None ☐ Mud ☐ Sludge ☐ Debris ☐ Grease
Silt Depth: **0** (in.) Deposits Extent:
Infiltration: **Evidence** Pipe Seal Cond: **Unknown**
